LIMITED MOLD ASSESSMENT

**Old Ronald McDonald House
15 Southeast 15th Street
Fort Lauderdale, Florida 33316**

GLE Project No.: 21000-23679

Issue Date: May 4, 2021

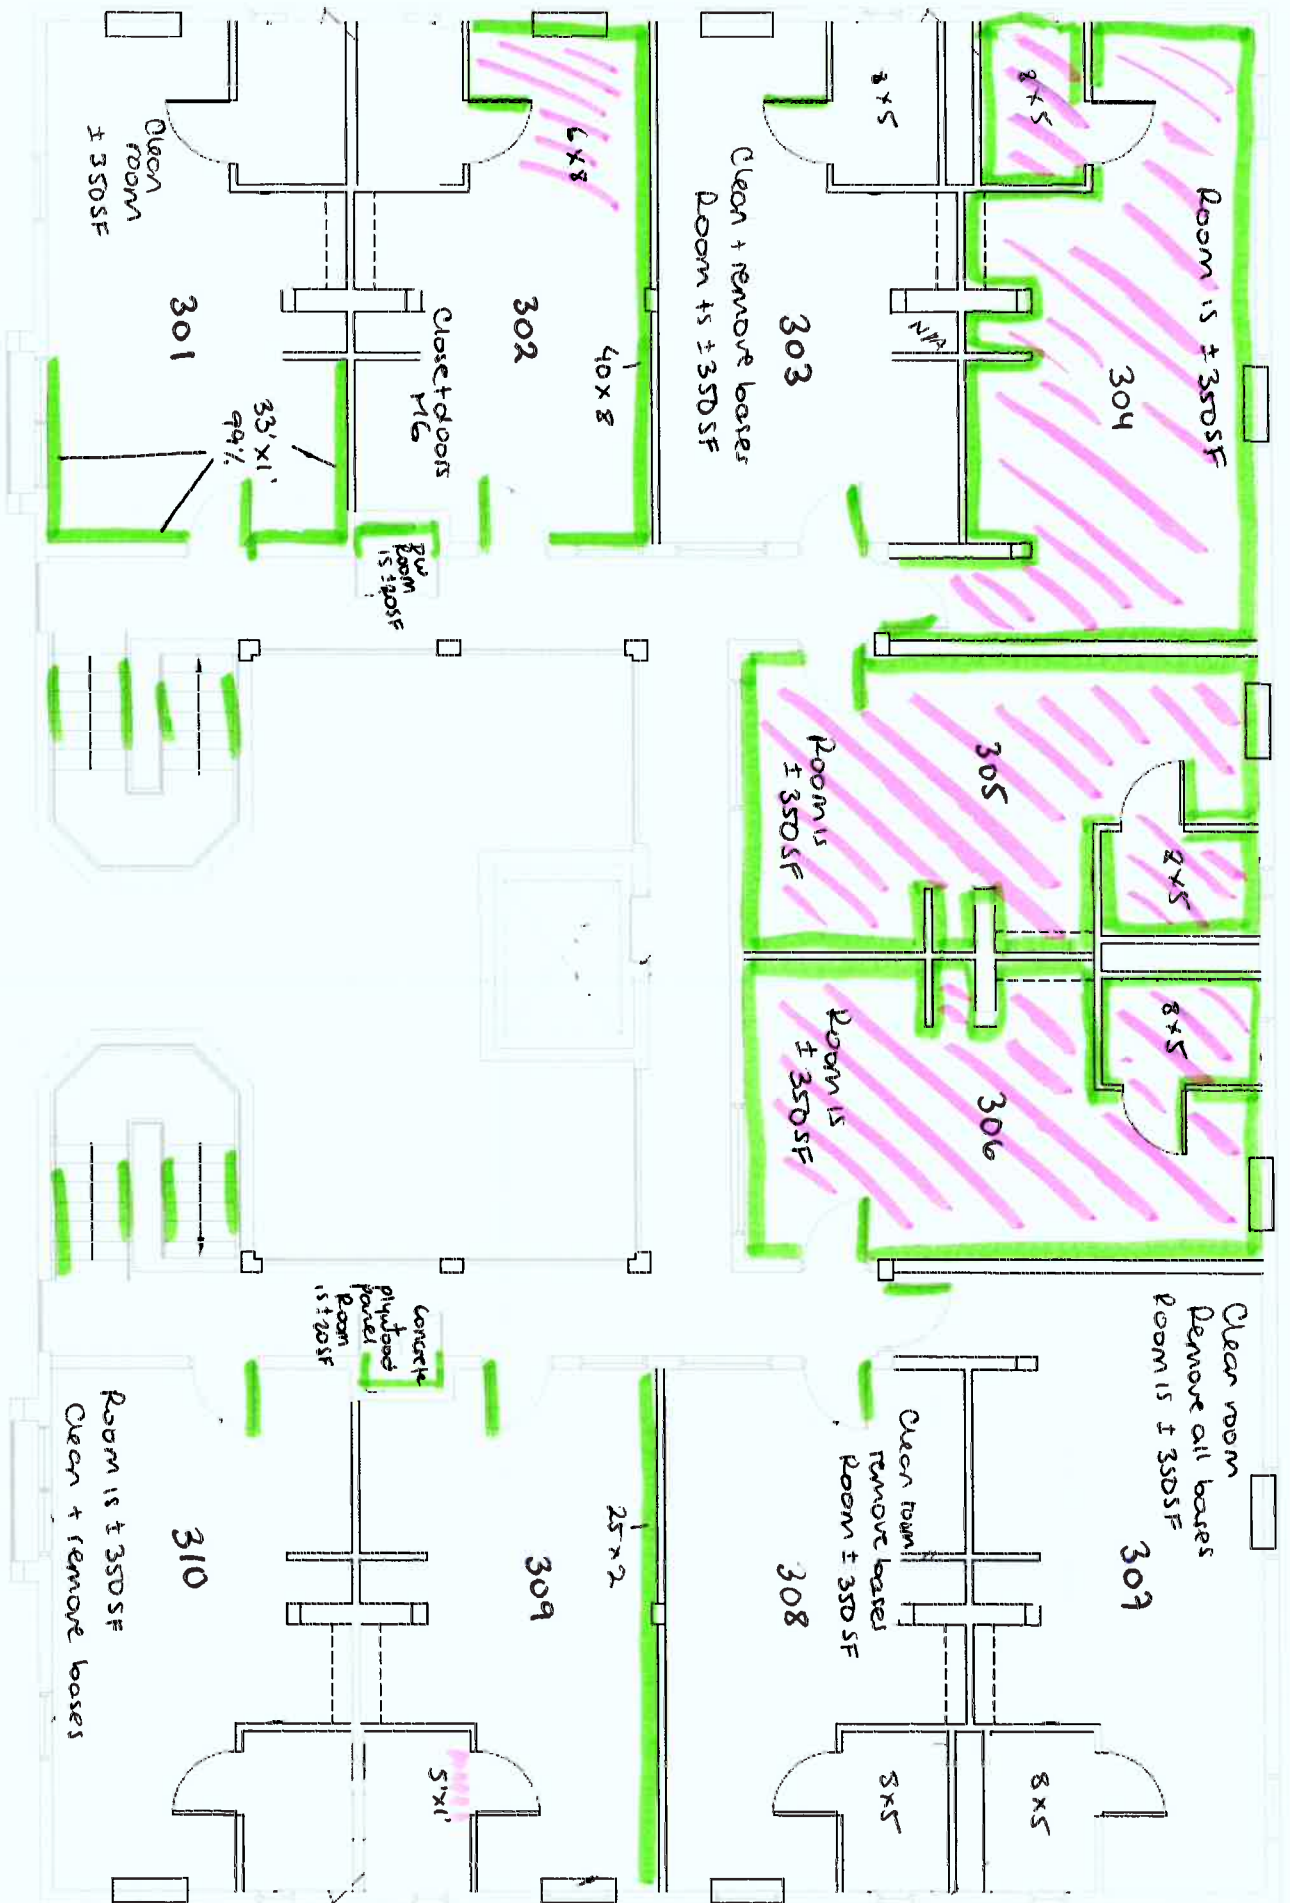
FLOOR PLAN - LEVEL 3

GLE performed a walkthrough visual assessment of accessible areas of concern within the scope of work. The assessment identified water and/or mold impacted materials, including, but not limited to, building materials exhibiting visible water staining, water damage, and/or mold growth. Visual observations are outlined in **Appendix D - Drawing**.

1. Visibly water-stained and mold-impacted materials were observed in the assessed areas as outlined in **Appendix D**.
2. The results for the bio-aerosol air sampling **are** indicative of interior airborne bio-amplification at the times, locations, and conditions of the sampling event.

1. All water-damaged/mold-impacted building materials identified in **Appendix D** should be properly remediated by a qualified mold remediation contractor in accordance with the remediation recommendations presented in **Appendix B - Remediation Recommendations**.
2. HEPA-filtered negative air machines should be operated in the re-circulation mode (scrubbing) to continuously filter the air within the identified portions of the site. The air scrubbing equipment should be relocated periodically to enhance the entrainment and subsequent filtration of airborne fungal spores within the identified portions of the site. Additionally, all horizontal surfaces within the identified portions of the site should be HEPA vacuumed and damp (not wet) wiped.
3. Properly evaluate and repair any deficiencies observed, associated with the building envelope and roof, to prevent water intrusion.

4. Properly remove and dispose of all mold and water damaged porous building materials identified in **Appendix D**.
5. Non-porous diffusers and return grilles, appliances, furniture, boxes and other miscellaneous items in remediation work areas should be thoroughly cleaned/scrubbed using wet-wipe cleaning utilizing a two-towel system with a microbial biocide agent and vacuums utilizing HEPA filters.
